Table 1. Post tests using the DeckLok fastener

Test Specifications

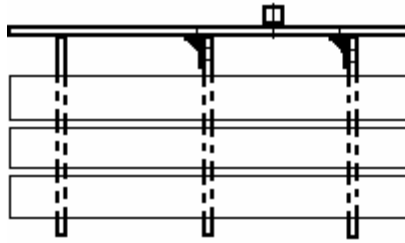
Figure 1. Test configuration 1

Test Configuration 1 (Figure 1)

You will notice that the limiting factor was either the wood materials or the testing equipment. Test specimen 1 represents a proof load to 500 lbf. This suggests that additional load carrying capacity was likely. For test specimens 2 and 3, the failure occurred in the post and rim board respectively. Therefore, the full load carrying capacity of the connection system was not determined for Configuration 1. That is, no failure was associated with the DeckLok connection, which suggests the DeckLok connection could carry additional load.

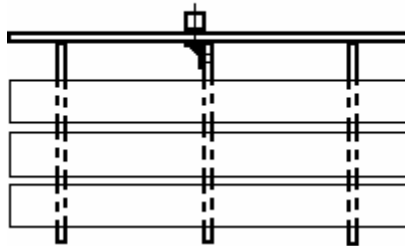
Figure 2. Test configuration 3

Test Configuration 3 (Figure 2)

For this configuration it appears that additional restraint for the joist containing the DeckLok connector should be improved. This would allow the DeckLok connection to received additional load. The average load carrying capacity for Configuration 3 was 832 lbf. Again these tests suggest that the DeckLok connection system is not the weak link.

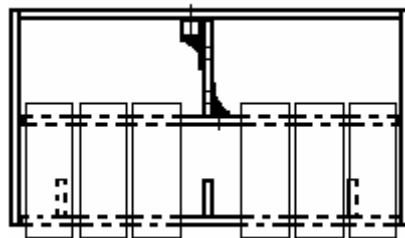
Figure 3. Test configuration 5

Test Configuration 5 (Figure 3)

In this configuration the blocking (containing the DeckLok connector) between the joists appears to be adequate to resist the load. The failure mode was one where the post pries the blocking and rim board away from the joist behind the rim board (Figures A10-A12). Here the joist behind the rim board is rotated and lifted upward. In test specimen 3 the blocking split, thereby separating from the joist behind. The average load carrying capacity for Configuration 5 was 565 lbf. Once again these tests suggest that the DeckLok connection system is not the weak link.

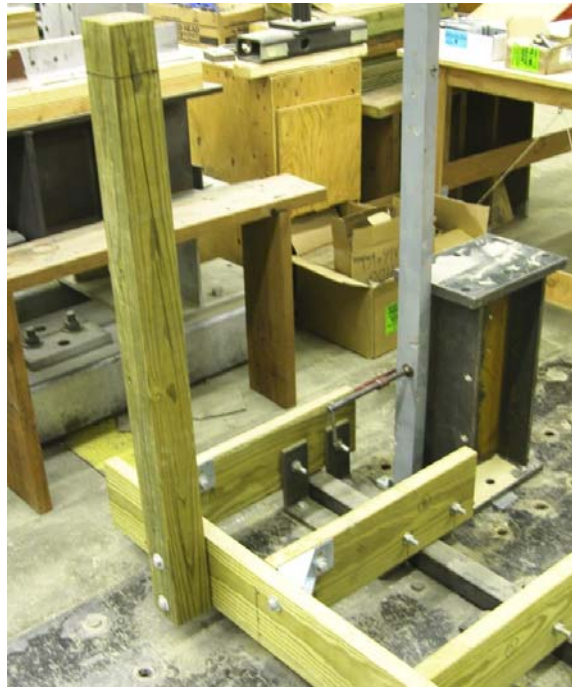
Figure A1. Test setup for configuration 1

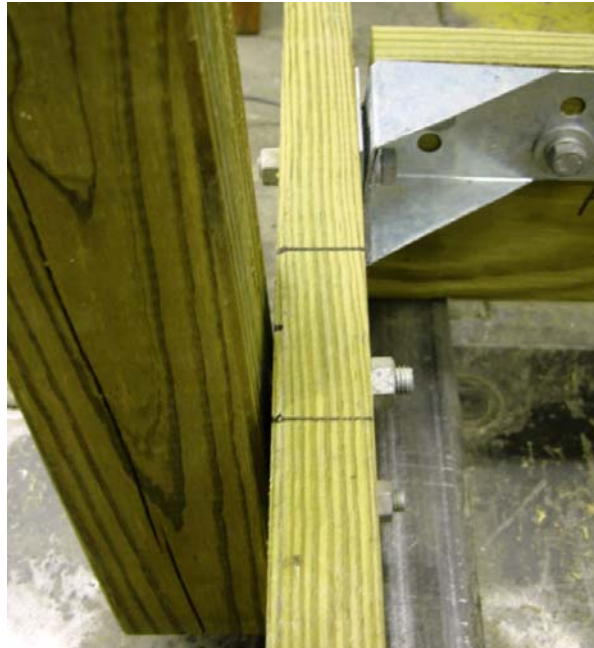
Figure A2. Failure mode for test specimen 1, configuration 1

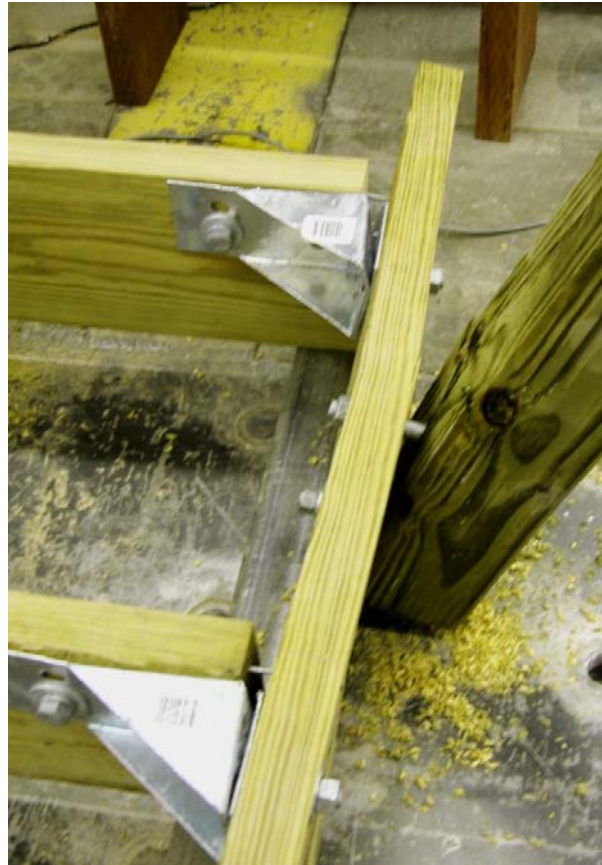
Figure A3. Failure mode for test specimen 2, configuration 1

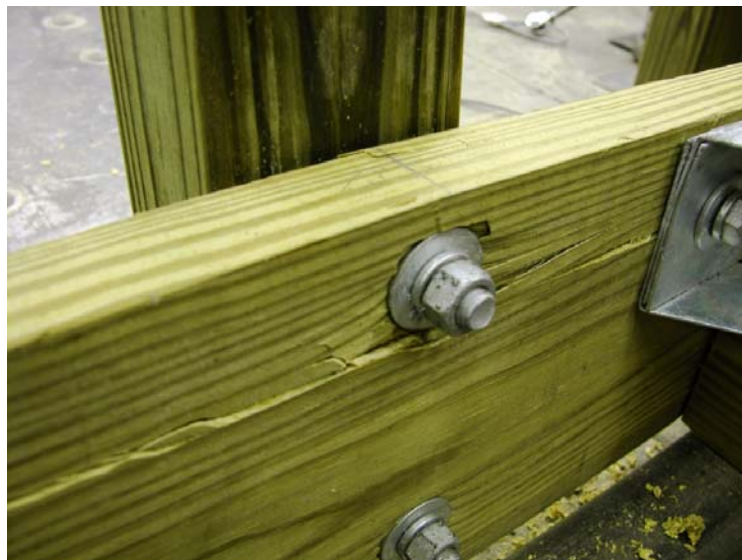
Figure A4. Failure mode for test specimen 3, configuration 1

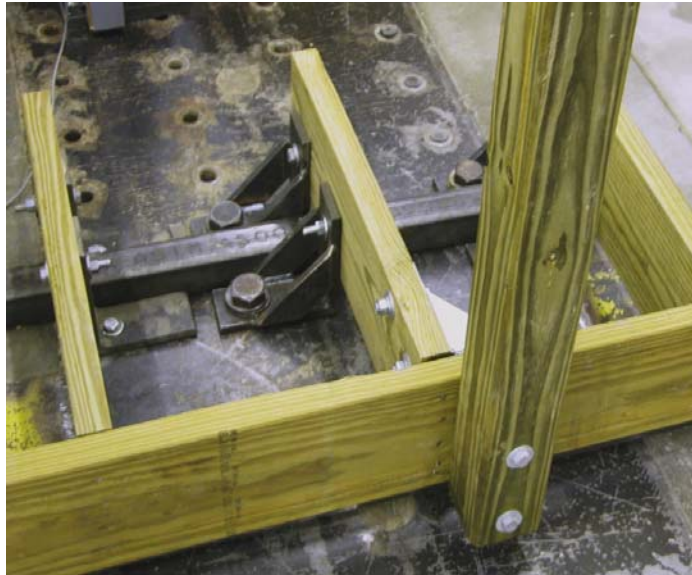
Figure A5. Test setup for configuration 3

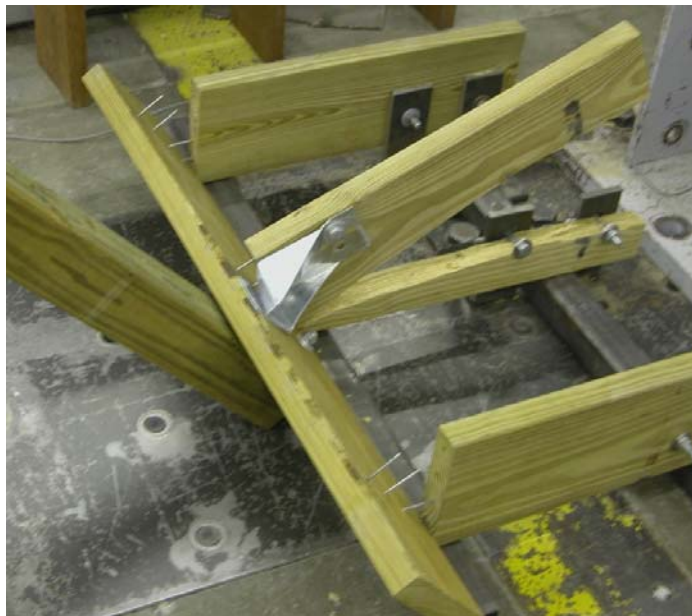
Figure A6. Failure mode for test specimen 1, configuration 3

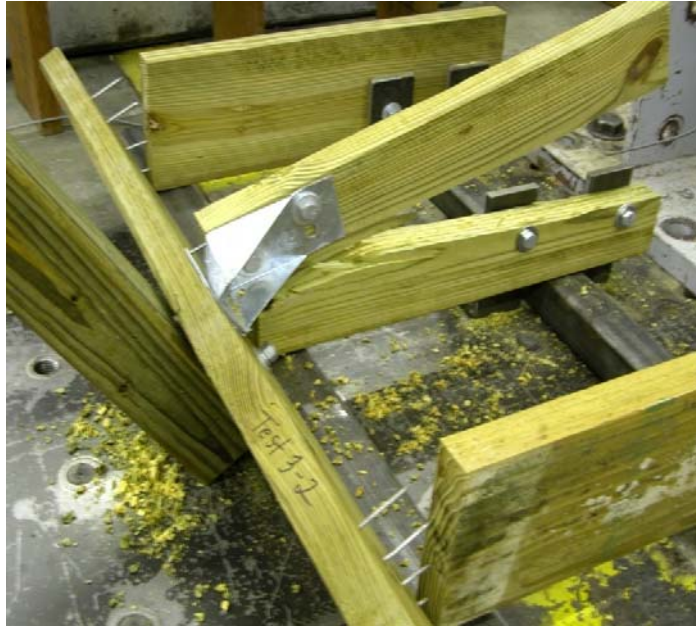
Figure A7. Failure mode for test specimen 2, configuration 3

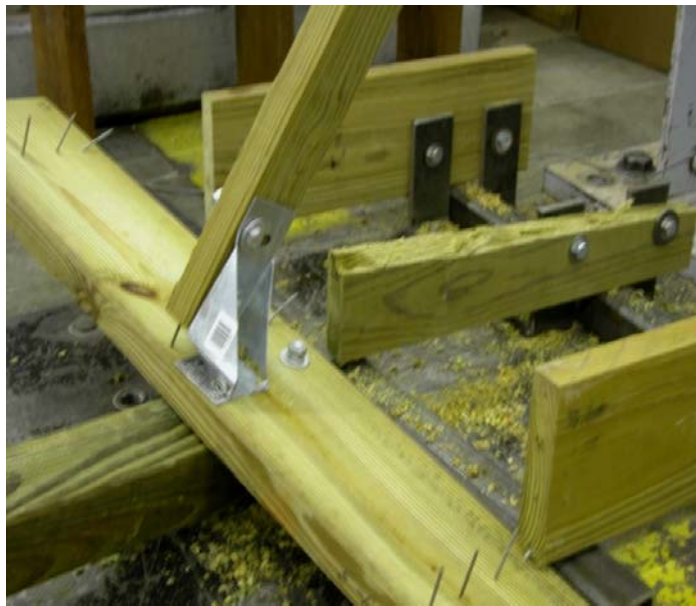
Figure A8. Failure mode for test specimen 3, configuration 3

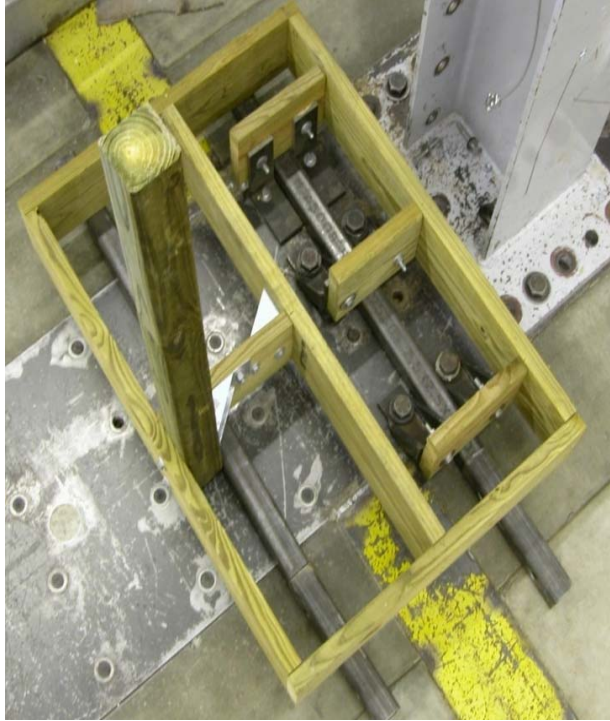
Figure A9. Test setup for configuration 5

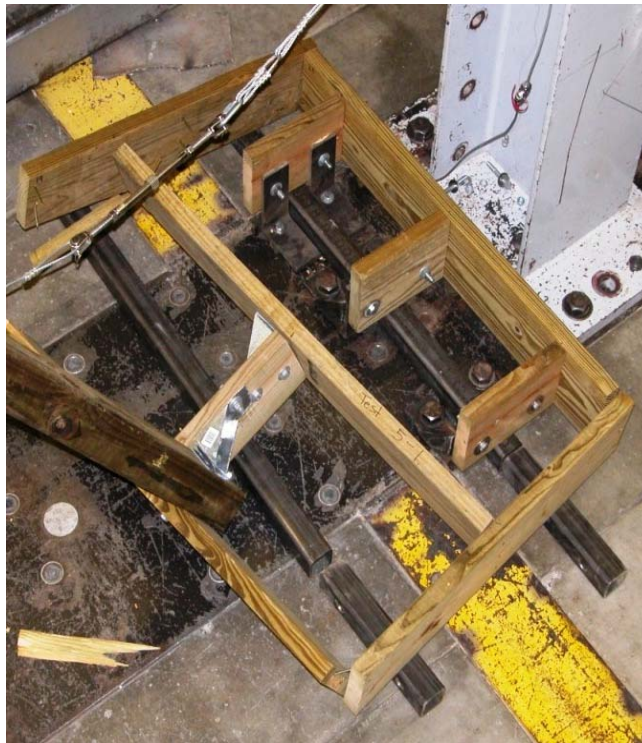
Figure A10. Failure mode for test specimen 1, configuration 5

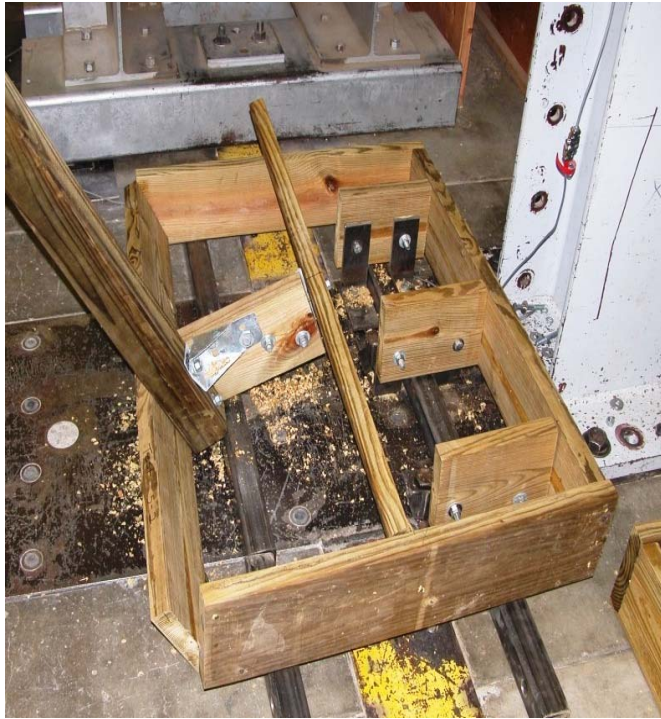
Figure A11. Failure mode for test specimen 2, configuration 5

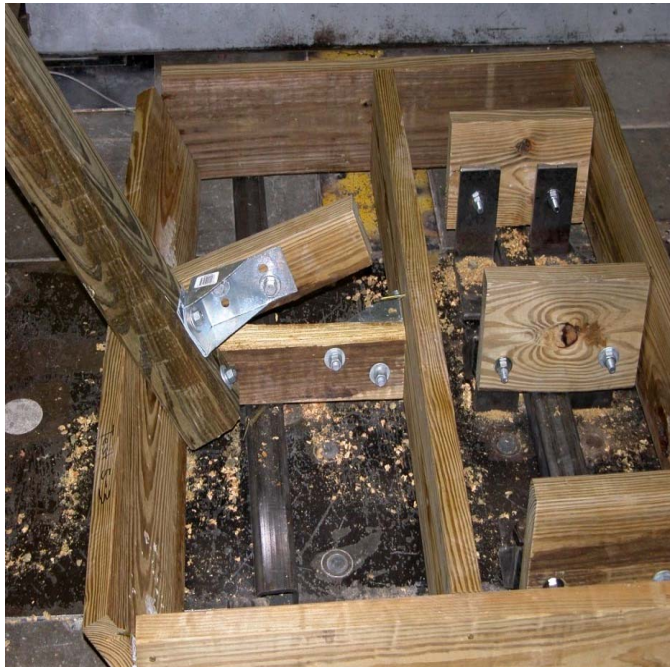
Figure A12. Failure mode for test specimen 3, configuration 5
